April 29, 2008

80-100 Charlotte Street Rochester, New York

This letter summarizes the decommissioning of eleven wells located at the above-referenced property (Site) in accordance with the scope of work outlined in a proposal dated March 14, 2008.

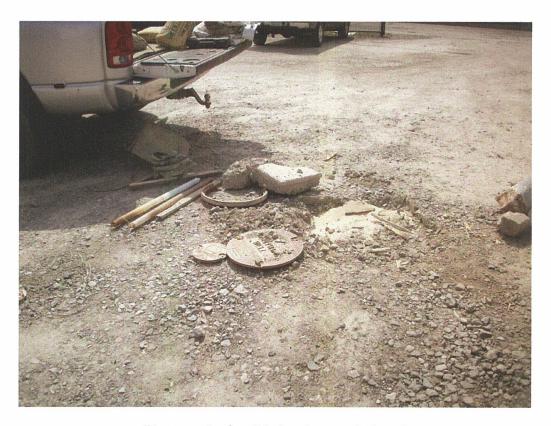
Photograph of well being decommissioned

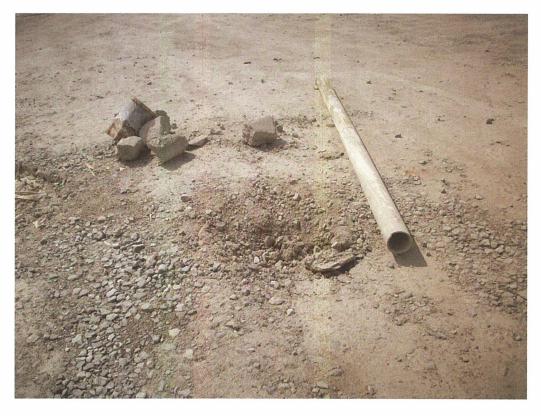
Photograph of well being decommissioned

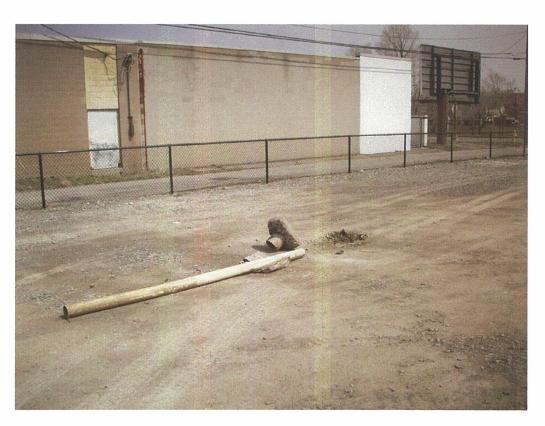
Photograph of well being decommissioned

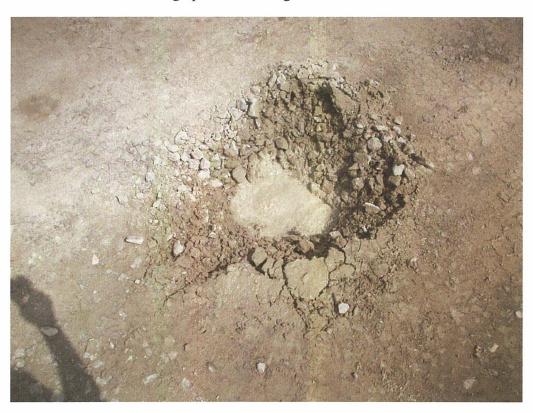
Photograph of cement/bentonite grout used to seal well

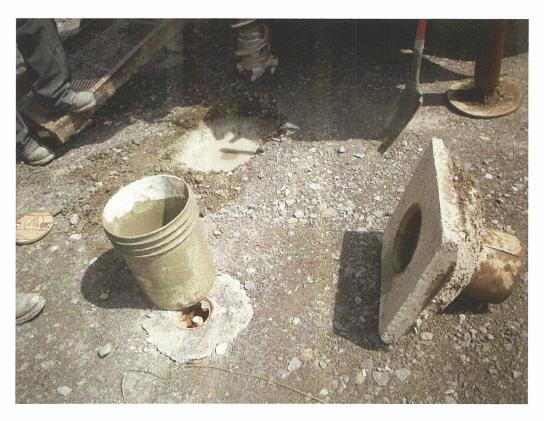
Photograph of well being decommissioned

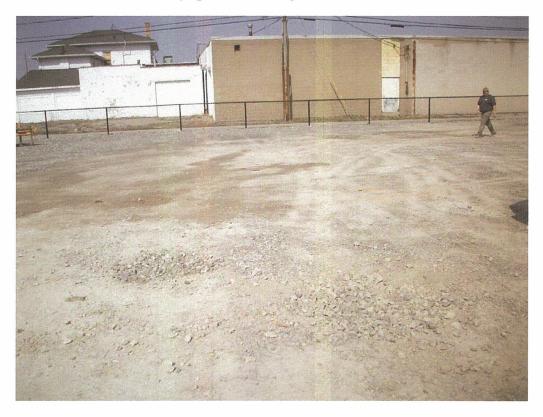
Photograph of decommissioned well location

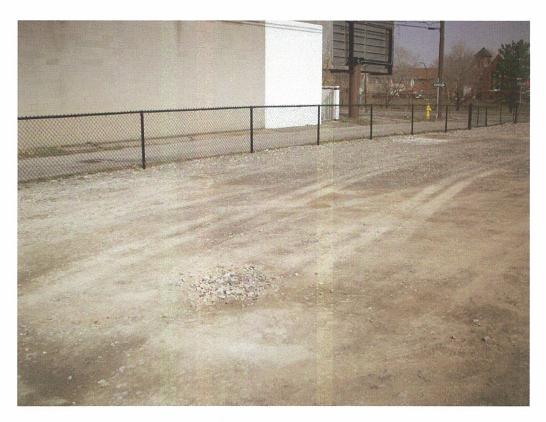
Photograph of decommissioned well location

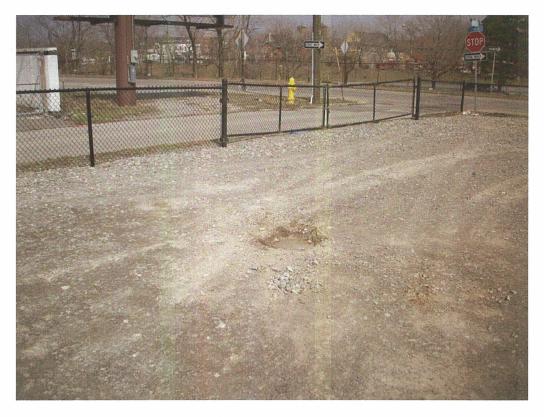
Photograph of decommissioned well location

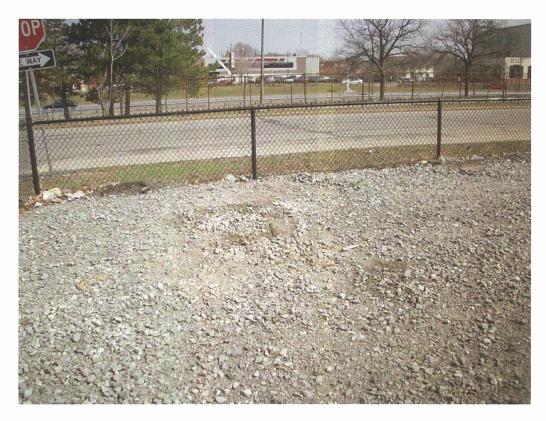
Photograph of decommissioned well location

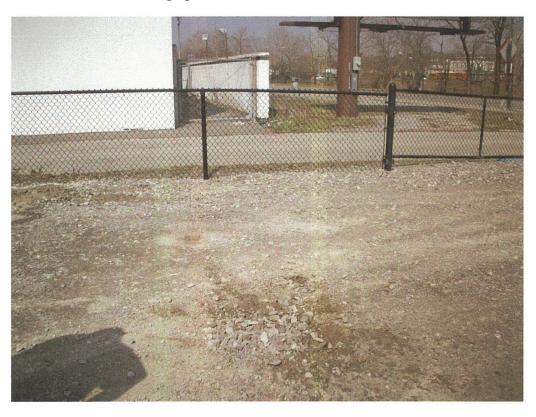
Photograph of decommissioned well location

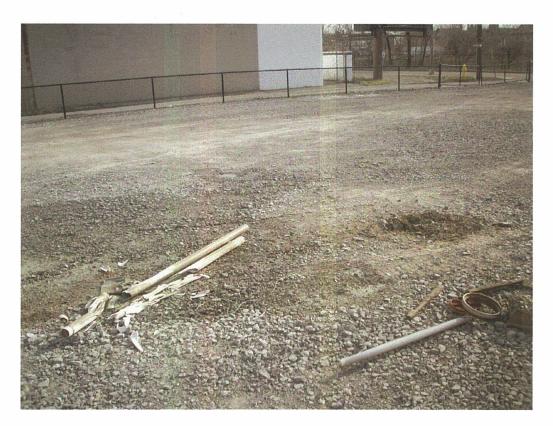
Photograph of well being decommissioned

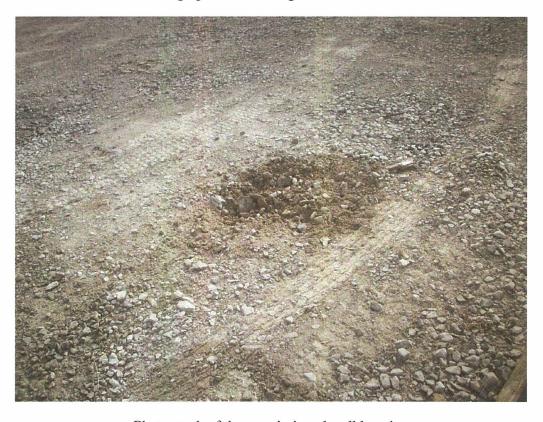
Photograph of decommissioned well location
